AFWAL-TR-82-4029

RAIN EROSION EVALUATION AND ANALYSIS OF  
SELECTED COATED MONOLITHIC POLYCARBONATE  
TRANSPARENCY MATERIALS

May 1982

Final Report for Period July 1980 - December 1981

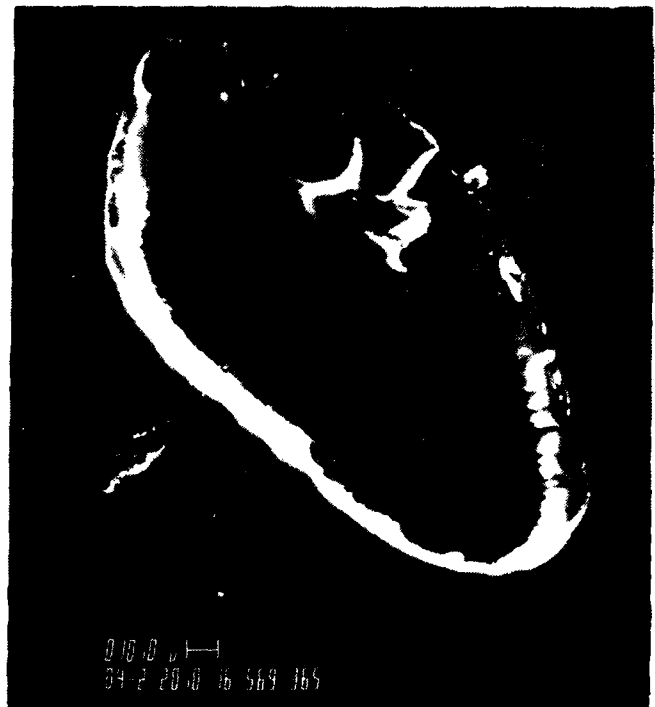
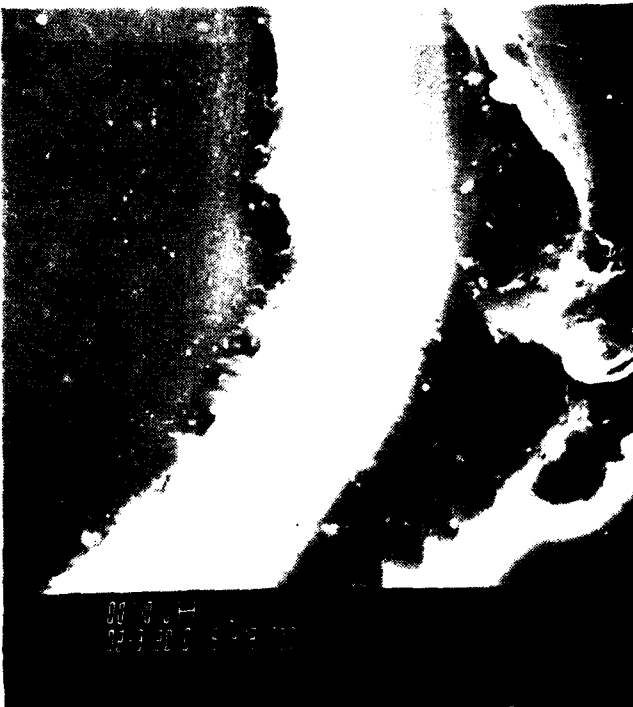
Figure B-9. Vendor B Coated Polycarbonate (3 Yr UV Exposure).

Coating removal in the Vendor B material was nearly zero percent, being independent of rainfield exposure time as well as UV radiation exposure effects (Figures 3, 4, and 5). The fact of no substantial coating removal on the Vendor B material could be associated with the existence of high adhesion forces between the coating and substrate interface. This may be deduced from Figure B-8B as well as from Figures B-7A and B-9C, where the coating itself was eroded prior to being delaminated from the substrate surface.

The initiation process was associated with the incubation time as shown by the kinetic curves in Figures 3, 4, and 5. The erosion process at the initiation stage was characterized by local erosion processes which resulted in the formation of isolated craters or pits in the range of 10 to 30  $\mu\text{m}$  in size (Figures B-1A and B-1B for the Vendor P coating, Figures B-4A and B-4B for the Vendor A coating, and Figures B-7A and B-9 for the Vendor B coating). These localized events consisted of material removal from the coating (Figure B-4B) as well as localized coating separation from the polycarbonate substrate (Figure B-9B).
